[A comparative surface topographical analysis of explanted total knee replacement prostheses: Oxidised zirconium vs cobalt chromium femoral components.](#)

*Medical Engineering and Physics* 2017, 50, 59-64

2 A comparative surface topographical analysis of explanted Total Knee Replacement  
3 prostheses: Oxidised Zirconium vs Cobalt Chromium femoral components

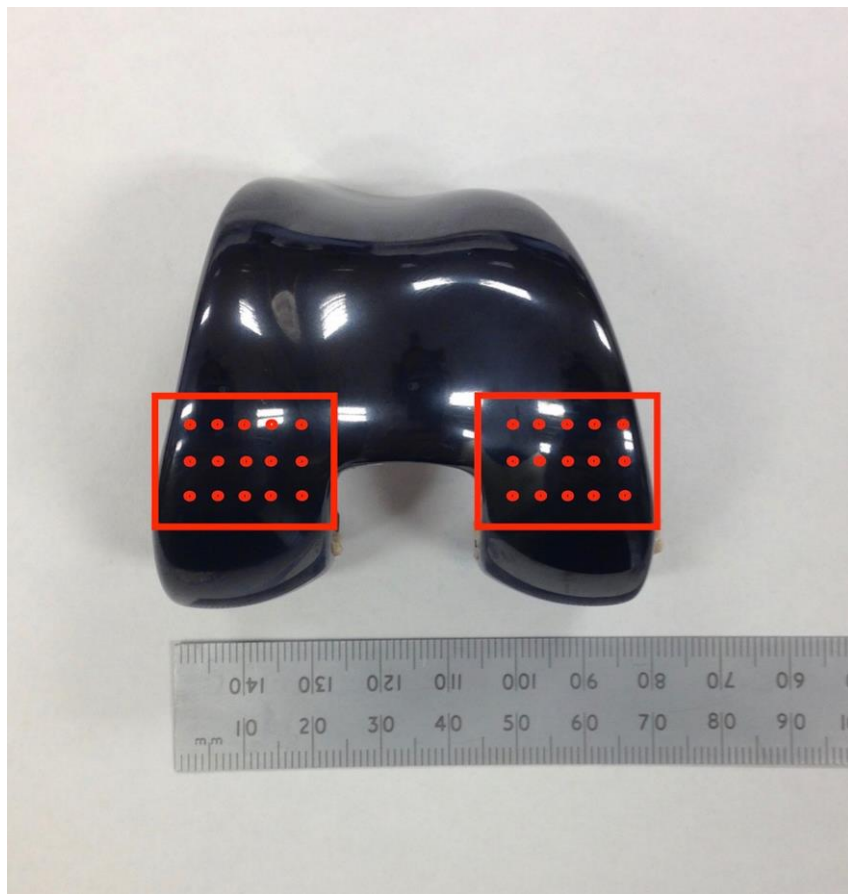
408 Figure 1.

388 Figure 1: Profilometer measurements were taken at approximately 30° flexion in the  
389 boxed areas as shown on this femoral component

141 skewness  $S_{sk}$  (the symmetry of the profile about the mean line) [28]. Fifteen  
142 measurements were taken at approximately  $30^0$  flexion on each femoral condyle (see  
143 Figure 1).

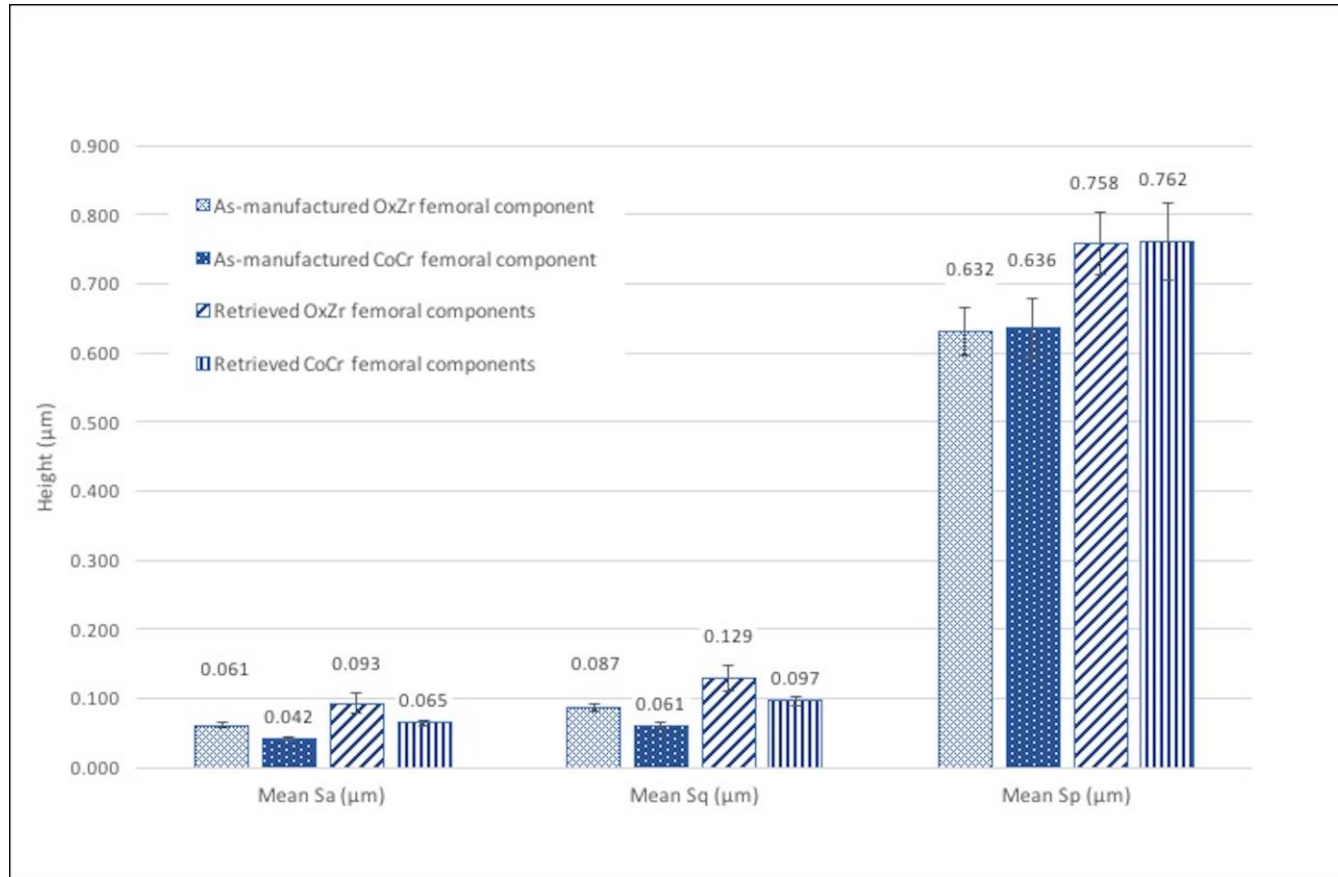
411 Figure 2.

390 Figure 2: Surface roughness parameters  $S_a$ ,  $S_q$  and  $S_p$  measured on as-manufactured  
391 OxZr and CoCr femoral components and retrieved OxZr and CoCr femoral  
392 components.

157 The roughness parameters,  $S_a$ ,  $S_q$ ,  $S_z$  and  $S_p$  were greater, and  $S_v$  and  $S_{sk}$  were more  
158 negative, for the retrieved than for the as-manufactured for both OxZr and CoCr  
159 femoral components. There were no significant differences between any of the  
160 surface roughness parameters measured on the retrieved OxZr femoral components  
161 compared to those measured on the retrieved CoCr femoral components (see Table 2  
162 and Figures 2 and 3). The  $S_a$  and  $S_q$  were both significantly greater ( $p < 0.001$ ) for the  
163 as-manufactured OxZr femoral component than for the as-manufactured CoCr  
164 femoral component.

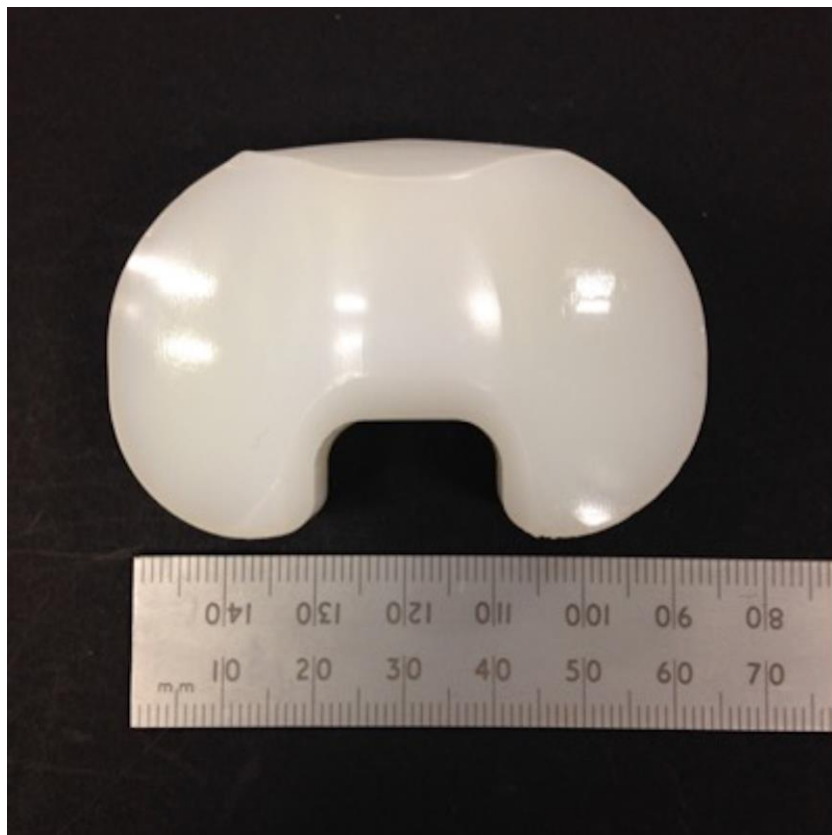
417 Figure 4.

396 Figure 4: A retrieved PE component from an OxZr TKR

165 All six of the retrieved PE components displayed *in vivo* damage with burnishing  
166 being the most prevalent damage mode observed; there was no embedded debris or  
167 delamination detected. Figure 4 shows a retrieved PE component with an area of  
168 burnishing and a pit approximately 1mm in size. The Hood damage scores are given  
169 in Table 1.
