1 **Sites of fractures in explanted NeuFlex metacarpophalangeal silicone prostheses**

2 T J Joyce, G Giddins*

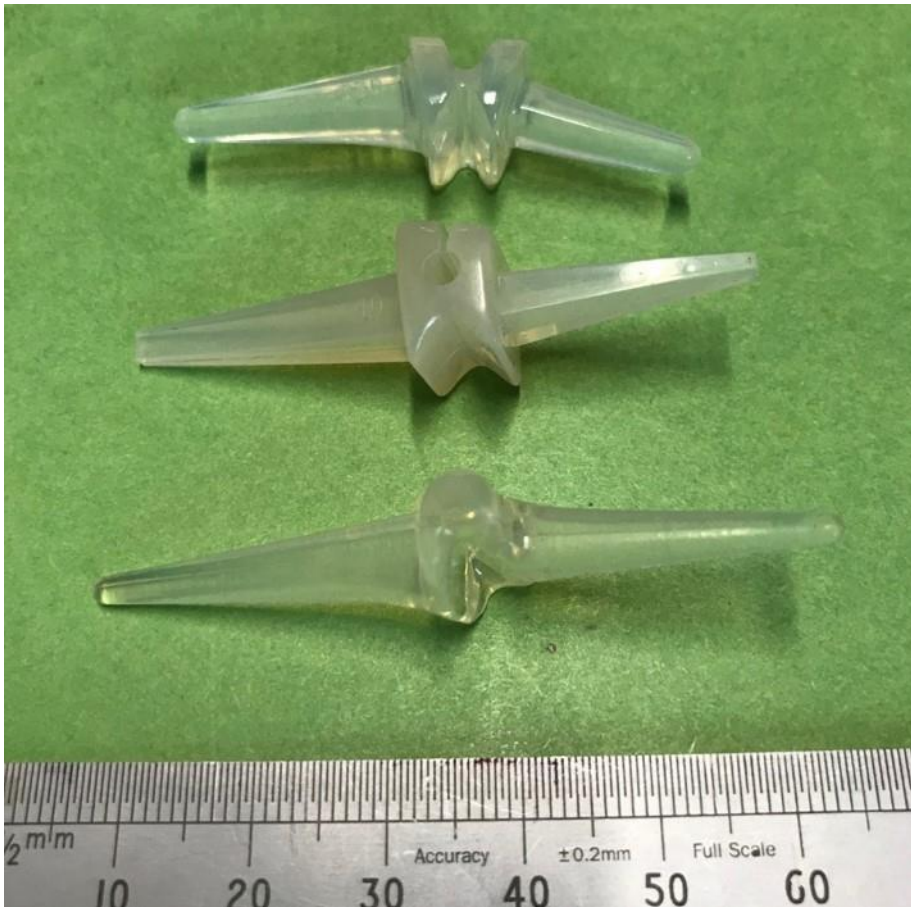
186 Figure 1 – different designs of silicone single-piece finger implants. Top NeuFlex, middle
187 Sutter/Avanta, bottom Swanson. In all cases the distal stem is to the right.

35 Single-piece silicone implants dominate finger arthroplasty of the metacarpophalangeal (MP) joint.
36 The Swanson (Wright Medical, Memphis, USA) implant is the market leader
37 (Norwegian_Arthroplasty_Register, 2016). Known 'problems' include fracture (Kimani et al., 2009),
38 primarily at the junction of the distal stem and hinge (Joyce and Unsworth, 2002). This position of
39 fracture is also seen with the Avanta/Sutter (Sutter Corporation/Avanta, San Diego, USA) single-piece
40 silicone finger implant (Joyce et al., 2003). It is thought to be particularly related to the dominance of
41 subluxing forces in the rheumatoid MP joint (Drayton et al., 2016; Joyce, 2009). In 1998 the pre-flexed
42 NeuFlex implant was introduced. The three designs, Swanson, Sutter and NeuFlex, are shown in Fig
43 1.

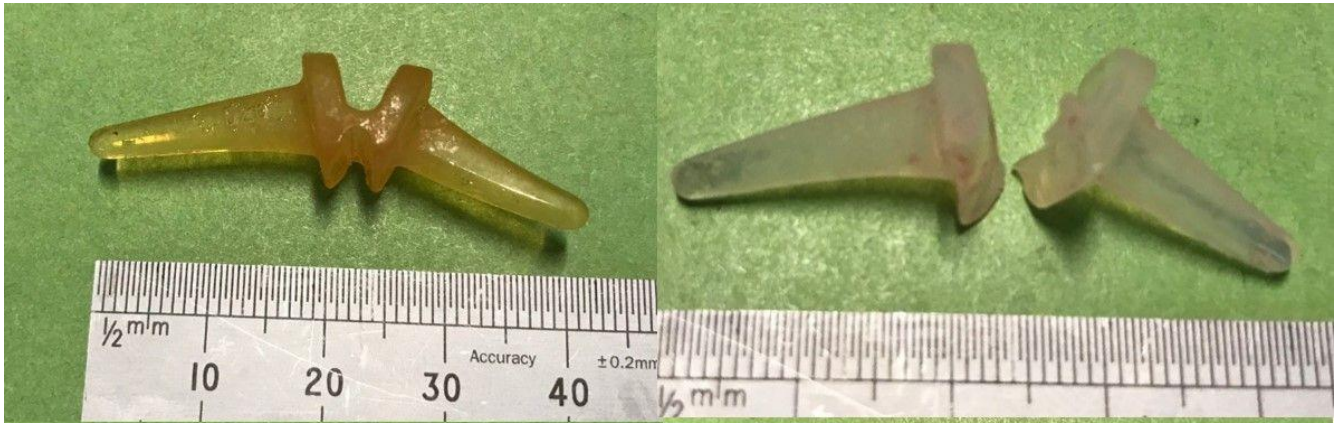
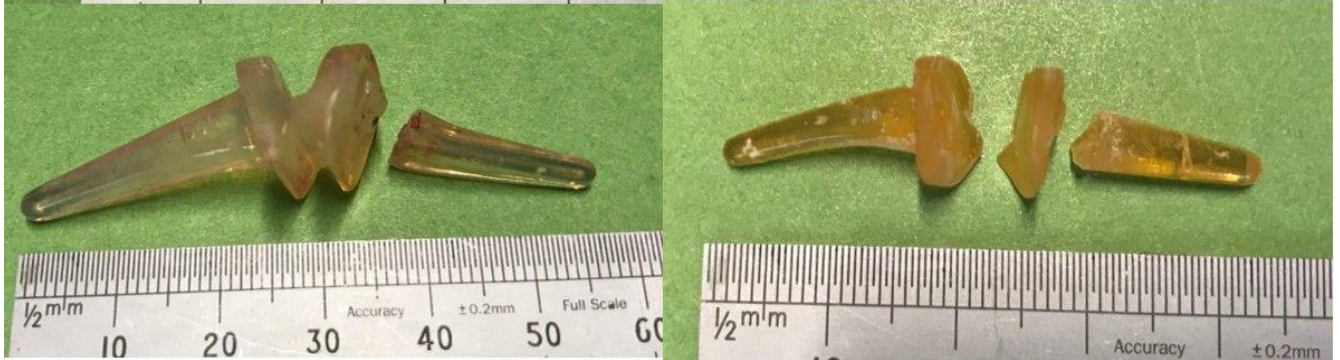
78 Seven explants were not fractured (Fig 2A). Eleven explants had completely fractured at the hinge
79 (Fig 2B). A further nine explants had completely fractured at the junction of the distal stem and hinge
80 (Fig 2C). Three explants had completely fractured at both the hinge and at the distal stem (Fig 2D).

188 Figure 2 A (top left) – An un-fractured NeuFlex explant (explant 15); B (top right) – A NeuFlex explant
189 (explant 28) showing fracture at the hinge; C (bottom left) – A NeuFlex explant (explant 24) showing
190 fracture at the junction of the distal stem and hinge; D (bottom right) – A NeuFlex explant (explant 13)
191 showing fracture at both the hinge and at the junction of the hinge and the distal stem

94 As shown in table 1, 11 NeuFlex explants had fractured across the hinge (Fig 2B); this has not
95 previously been reported in vivo. Fracture at the hinge occurred when three NeuFlex implants were
96 tested in vitro in a finger function simulator (Joyce and Unsworth, 2005). Nine NeuFlex explants had
97 fractured at the junction of the distal stem and hinge (Fig 2C). This is similar to the site of implant
98 fracture seen with Swanson implant fractures (Gellman et al., 1997; Trail et al., 2004) and
99 Sutter/Avanta (Joyce et al., 2003) implant fractures. In vitro tests have shown that Swanson (Joyce
100 and Unsworth, 2000) and Sutter (Joyce et al., 2003) implants fracture at the junction of the distal hinge
101 and stem, in both cases matching clinical experience.

102 Intriguingly, 10% of the cohort fractured at the hinge and at the junction of the distal stem and hinge
103 (Fig 2D). The authors are not aware of such a failure mode having been reported previously. That it
104 happened in three explants, and that one of the un-fractured NeuFlex explants (no. 19) also showed
105 substantial damage at both the hinge and the junction of the distal stem and hinge indicates that the

106 failure mode was not an anomaly; of greater note 11 (37%) fractured just at the hinge. Overall 14
107 (47%) suffered fractures of the implant hinge. Silicone implant hinge fractures have not previously
108 been reported. It is unclear whether this occurs before, after or separate to stem fractures.

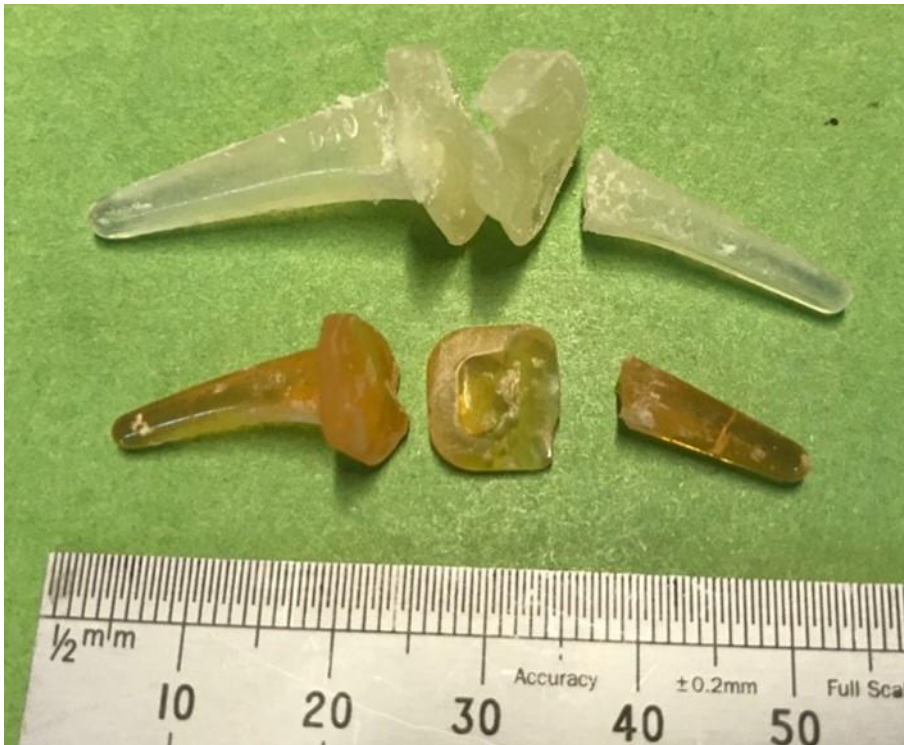
88 Discolouration of some explants had occurred (Fig 3). The significance of this is unclear but it could
89 represent some change in material properties of the implant.

192 Figure 3 – Two NeuFlex explants (explant 18 above and explant 13 below) showing discolouration.
193 Note that discolouration of explant 13 has occurred to the entire material and not just the outer
194 surfaces.

111 Discolouration of most explants occurred (Fig 3) likely indicating that the silicone material can change
112 when in the body. This may affect the material properties of the implants and could therefore be a
113 useful area for future research.
