1 Retrieval analysis of an explanted Mobi-C cervical disc replacement: A case study

2 Göksu Kandemir^a, Marina Pitsika^b, Justin J. Nissen^b, Andrew Bowey^c, Thomas J. Joyce^a

3 ^a*School of Engineering, Newcastle University, Newcastle Upon Tyne, UK*

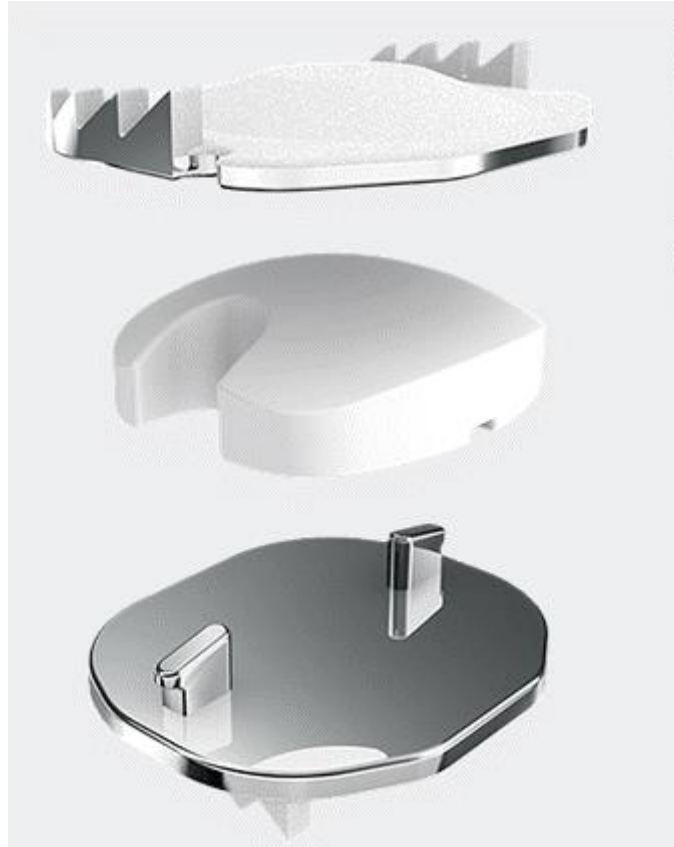
103 The articulation of the Mobi-C cervical artificial disc consists of a ball-in-socket. Mobi-C cervical discs
104 have three components: CoCr inferior and superior discs, and a non-constrained, mobile UHMWPE
105 insert. The components are shown in figure 1. The insert sits between the inferior and superior discs.
106 The backsides of the CoCr discs are titanium and hydroxyapatite coated [18]. The superior metallic
107 plate has a recessed spherical contact surface, and the inferior metallic plate has a flat contact surface.
108 Thus, the dome-shaped UHMWPE insert makes a spherical contact with the superior plate with its
109 curved surface and a flat contact with the inferior plate with its flat surface. Both CoCr end plates have
110 two rows of teeth (figure 2b) on their back surfaces (bony interface) opposite to their articulating
111 surfaces. The teeth are designed to improve the initial and long-term fixation of the implant [18]. On

Figure 1 The Mobi-C cervical disc [23]

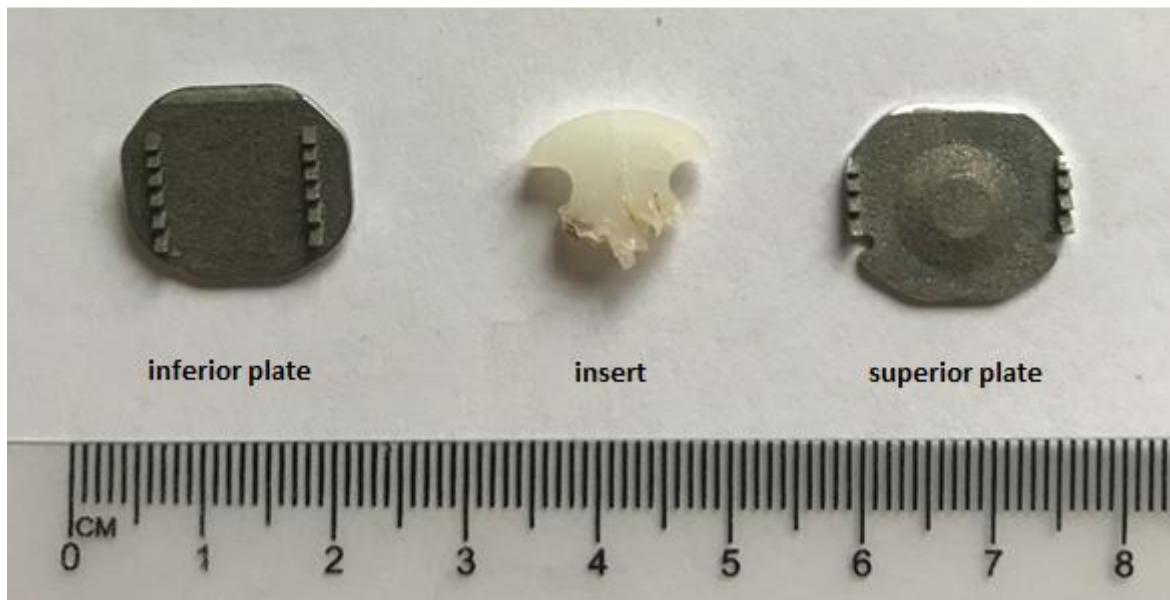
112 the inferior plate, there are two lateral stoppers, shown with arrows in figure 2a, that limit the
113 movement of the UHMWPE insert. The superior plate articulates with the insert and the insert slides
114 across the inferior plate [23].

118 *Figure 2 a) The articulating and b) backsides of the inferior (caudal) and superior (cranial) CoCr end plates and UHMWPE*
 119 *insert of the explanted Mobi-C cervical disc. The arrows show the lateral stops on the inferior plate.*

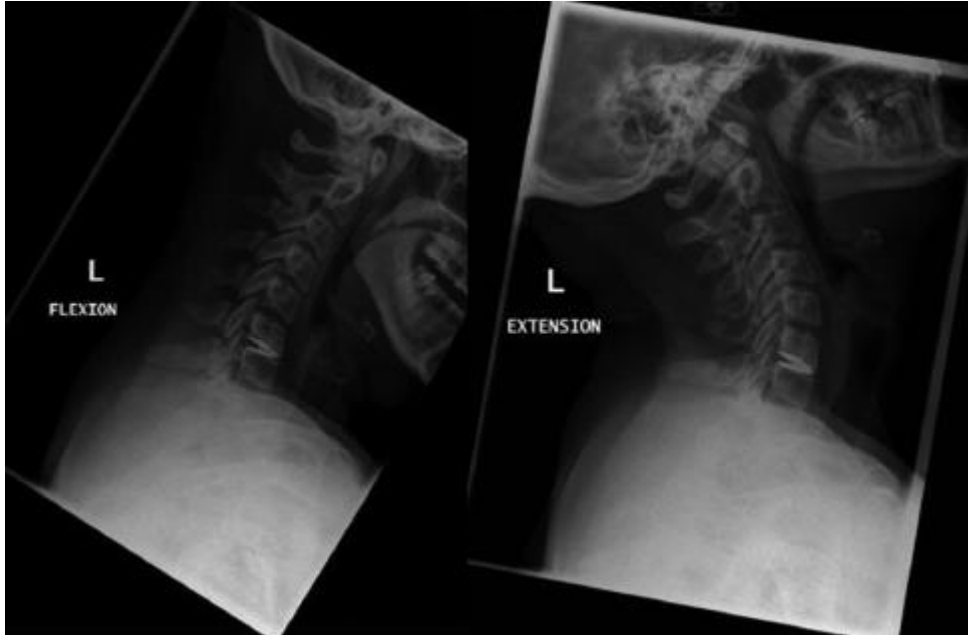
151 with a three-year history of worsening myelopathy. She underwent extensive investigations to identify
152 the cause for the clinical deterioration. Dynamic (flexion-extension) X-rays of the patient are shown in
153 figure 3.

Figure 3 The pre-operative dynamic X-ray images [30].

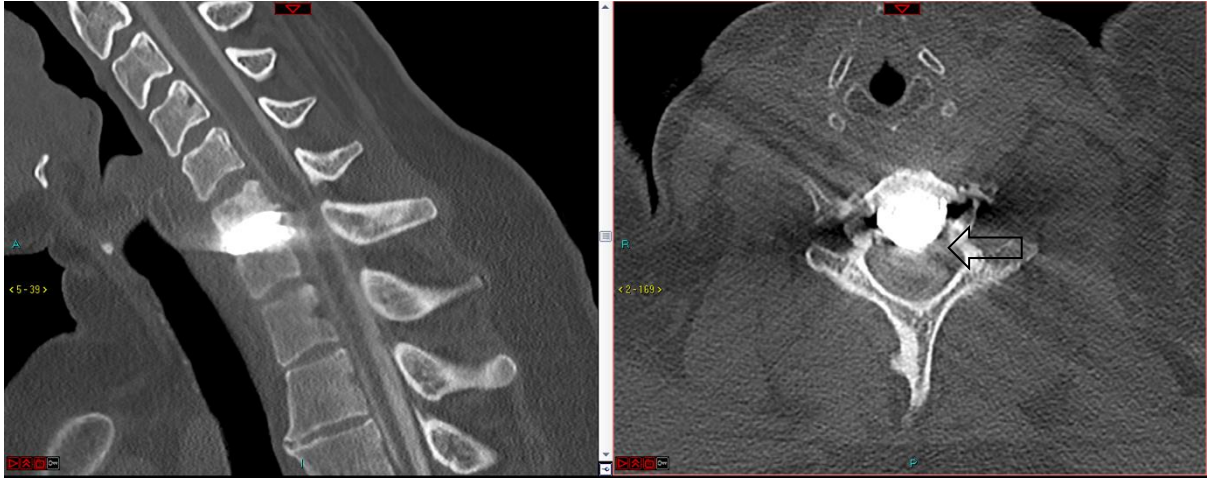
Figure 4 The CT myelogram showing the ⇒ compressed spinal cord in sagittal (left) and axial views (right) [30].

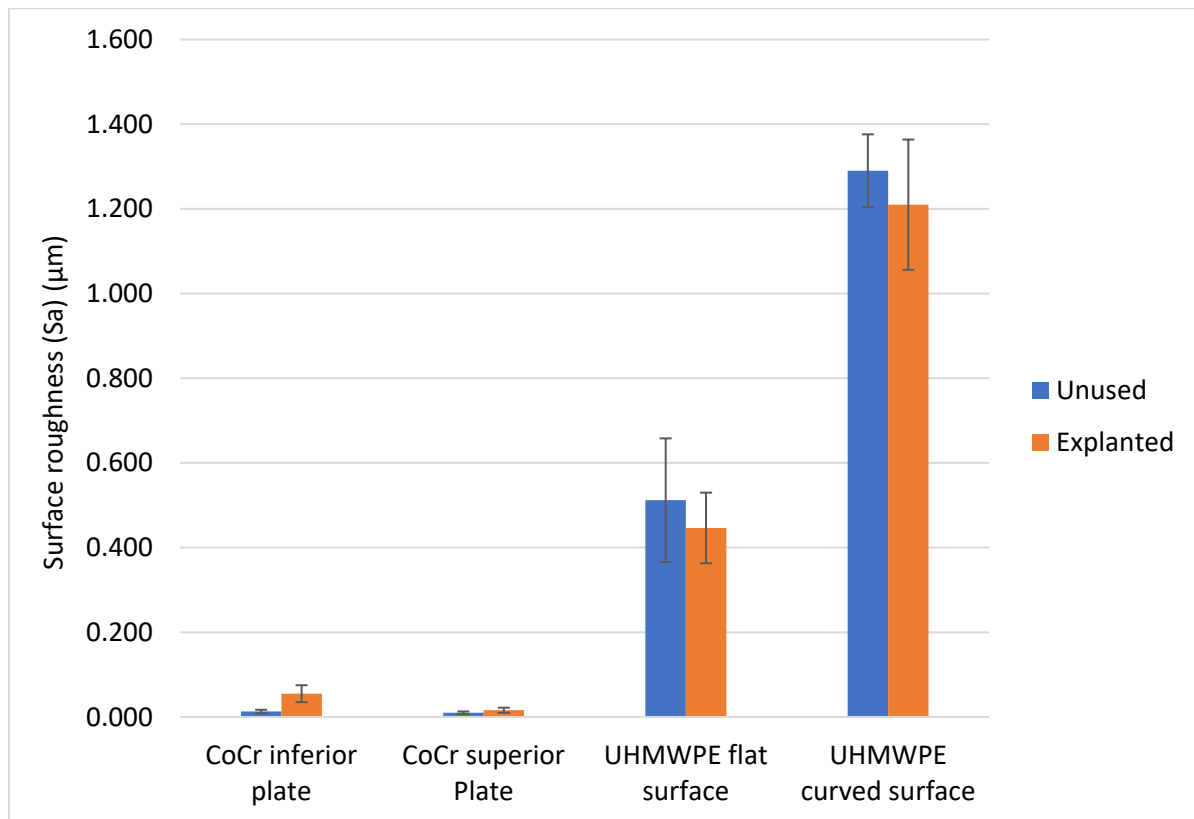
186 which states that the roughness of a metal prosthesis should be $R_a < 50$ nm. The comparison with the
 187 measured values from the explant gave an estimation of how the surface profile changed in vivo (figure
 188 7).

189
 190
 191 *Figure 7 Surface roughness of the articulating surfaces of the unused surfaces and the explanted Mobi-C artificial disc.*

192 The statistical analysis (z-test) for a 95% confidence level of the initial and final values of the surface
 193 roughness returned p-values of 0.04, 0.37, 0.70 and 0.65 for the inferior plate, superior plate, flat
 194 surface of the insert and curved surface of the insert, respectively. The difference was only significant
 195 for the inferior plate. Sample Zygo images for the articulating surfaces are given in figures 8 and 9 for
 196 the UHMWPE insert and CoCr plates, respectively.

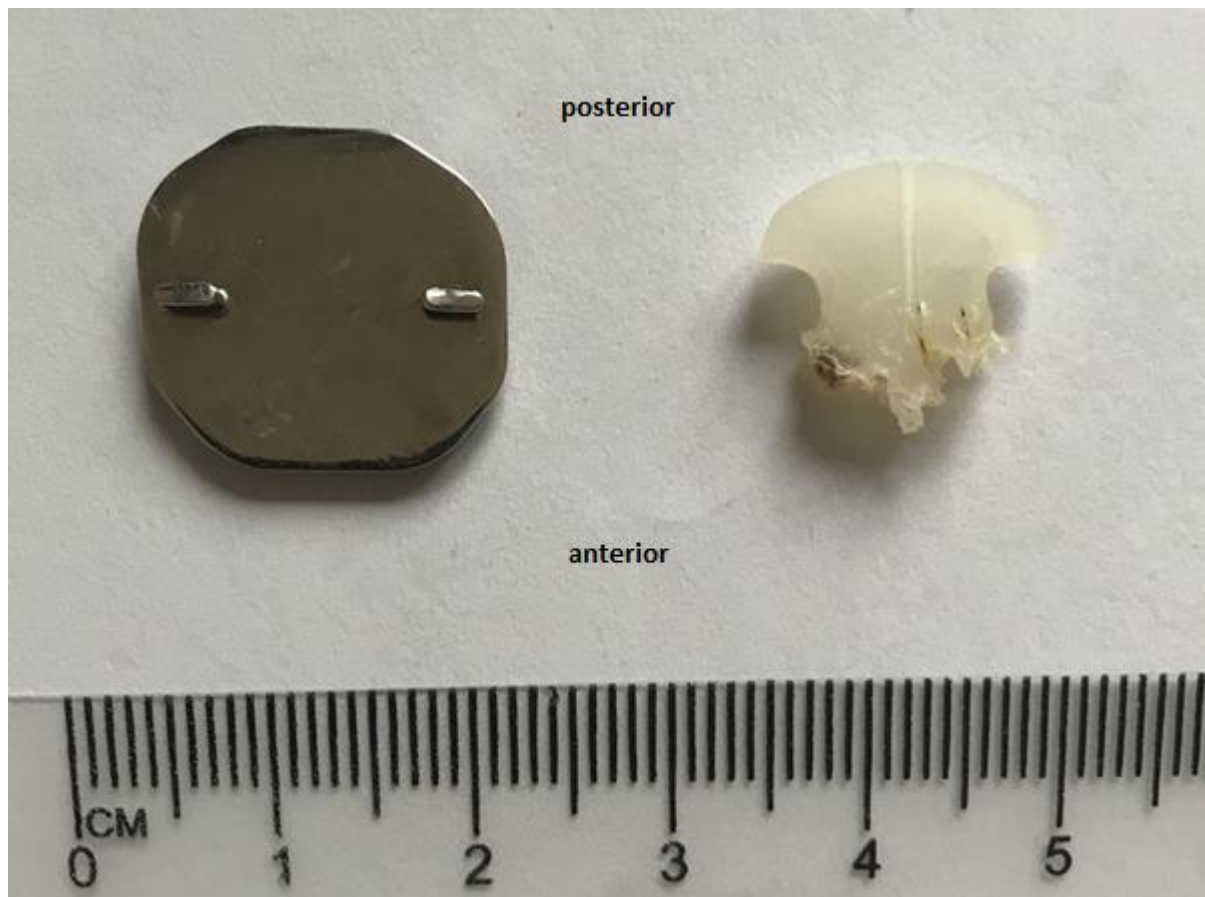
207 The flat contact surface formed by the inferior plate and the flat surface of the insert is shown in figure
 208 10.

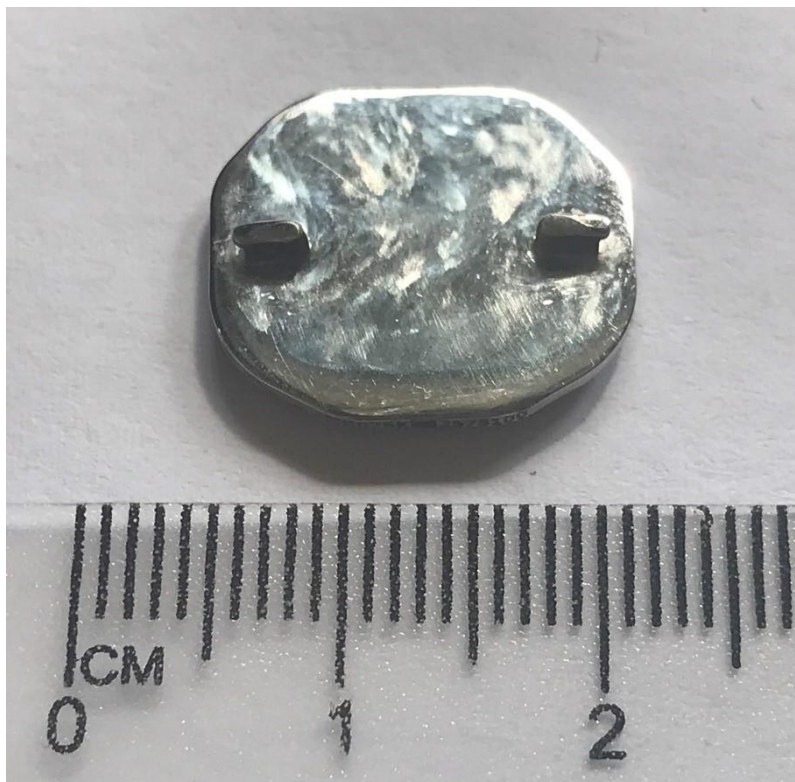
Figure 12 The articulating surface of the inferior CoCr endplate.

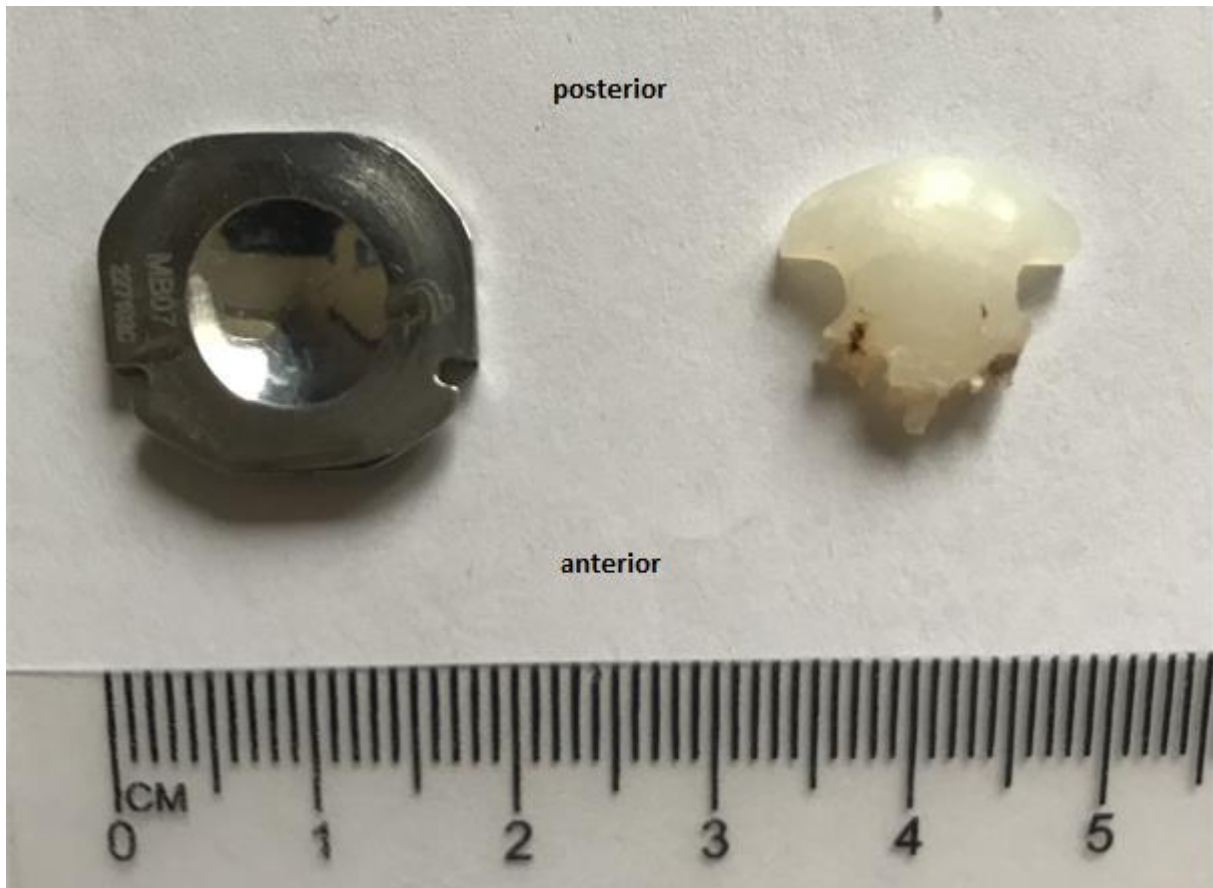
226 The spherical articulation formed by the superior plate and the curved surface of the insert is shown
227 in figure 13.
