Data in brief

Data Article

Dataset on mechanical properties of damaged fibre composite laminates with drilled vent-holes for resin-injection repair procedure

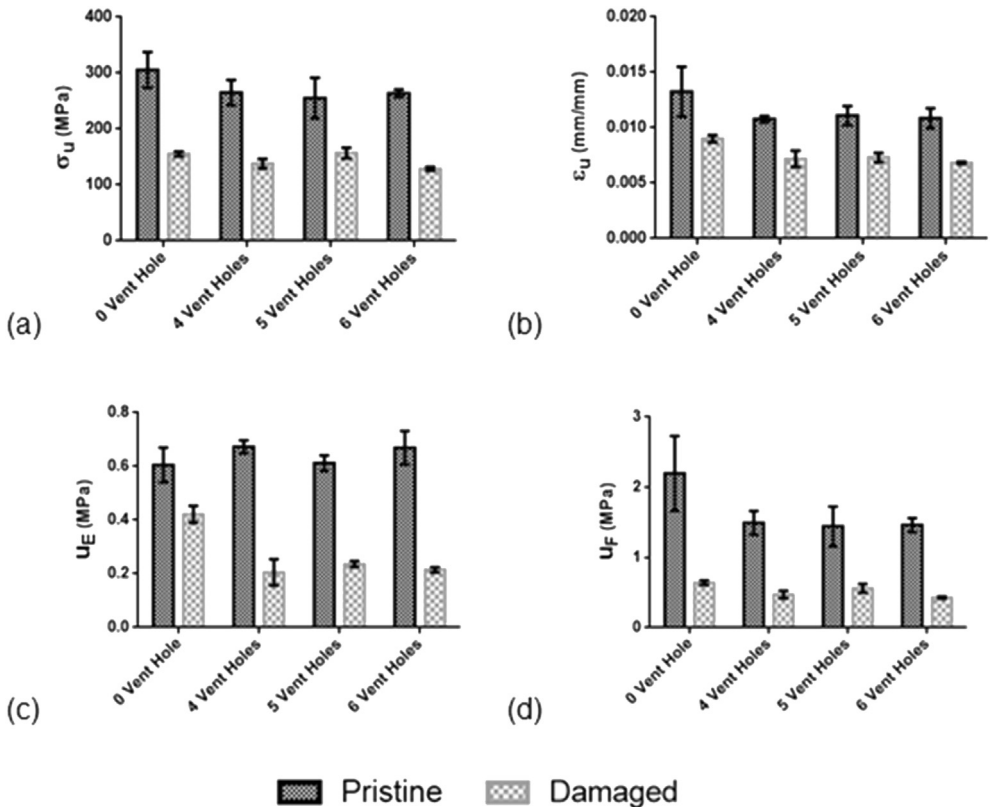
Fig. 1. Bar charts of the mechanical properties of CFRP samples with varying number of vent holes in pristine and damaged state. (a) Compressive strength, σ_U . (b) Compressive strain to rupture, ϵ_U . (c) Strain energy density for resilience, u_E . (d) Strain energy density to fracture, u_F . Results are shown for sample mean and standard error of mean.

[Fig. 1](#) shows the data of the mean and standard error of the mean value derived from the data ([Table 1](#)) of the mechanical properties for the four-level treatment with respect to number of vent holes.

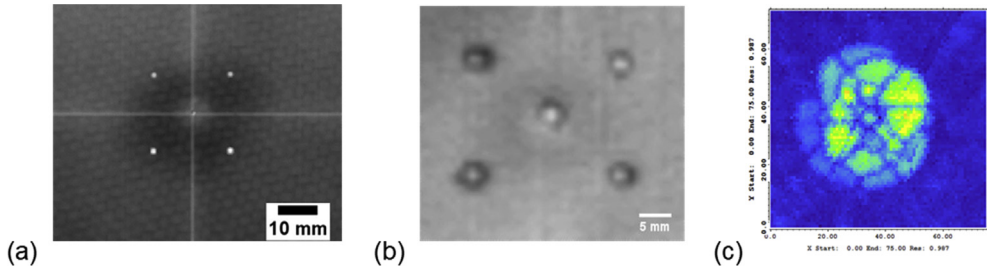
Fig. 2. Images of the BVID CFRP laminates acquired by ultrasonic C-scan and Infrared thermography. (a) Thermogram of BVID in a CFRP laminate. (b) Magnified view of the thermogram in panel a, revealing the damage around the holes. (c) C-scan image of BVID in CFRP laminate.

[Fig. 2](#) shows typical structural features of the CFRP laminates derived from infrared thermography and ultrasonic c-scanning, respectively. Panel a shows a BVID laminate sample in full view. The centre circular hole represented the resin-injection hole; the four white circular holes around the centre hole indicated the vent holes. These holes were drilled after the laminate was subjected to quasi-static indentation (QSI) to generate BVID [1,2]. Panel b shows a close-up image of the damage around the respective vent holes. Panel c shows an ultrasound c-scan image of the BVID within the laminate specimen. The complete dataset of images resulting from this method can be found in a MS Excel file ([Images_dib.xlsx](#)).
