DIC DEFORMATION MEASUREMENT IN CRACKED CFRP CROSS-PLY LAMINATES

Keywords: DIC, Cross-ply laminates, Matrix cracks, Secondary damage mode

ABSTRACT

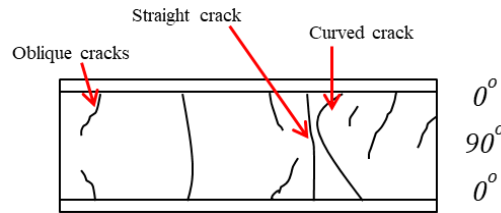
Figure 1: Schematic of the matrix crack pattern in CFRP $[0_4/90_{24}]_s$ laminate.

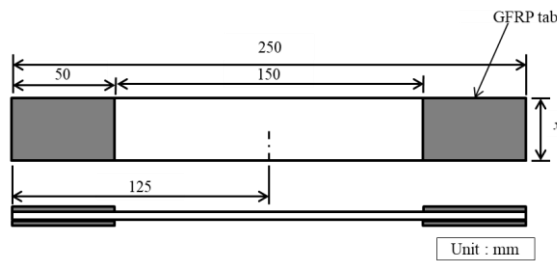
Figure 2: Specimen's measurement.

The prepregs are stacked according to the stacking sequences shown in Table 1 and cured in an autoclave at a temperature of 130 degree Celsius and pressure of 0.2 MPa. Laminates are then cut into the measurement shown in Figure 2 by using a composite material cutting machine (AC-300CF, Maruto Testing Machine). In order to make sure matrix cracks uniformly occur on the specimen for easier damage observation by X-ray radiography and DIC system, the artificial crack method is induced in this study. This method is explicitly explained by Fikry et al. [6] where artificial crack method can be done by making notches at both edges of the specimen by using a knife before pulling it in a tensile test machine with cross head speed of 1mm/min to a specific load. Then the specimen is unloaded back to zero and the notched edges are cut by using composite material cutting machine mentioned above at ± 5 mm from the edges.

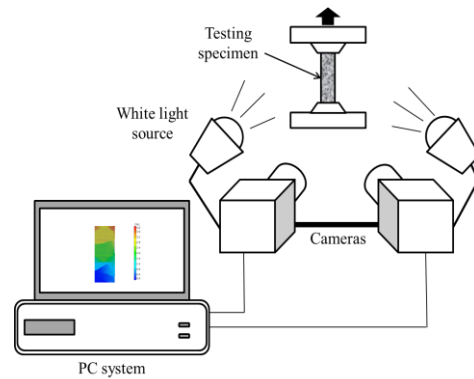
Figure 3: Schematic figure of DIC setting.

Then, DIC apparatus is set up as shown in Figure 3 where tensile machine is different with the one used to obtain the mechanical properties of the laminates. The tensile test machine used in DIC observation is Shimadzu AG-X Plus and the cross head speed for this loading is maintained at 1mm/min. ARAMIS sensor unit is operated on a stand in order to optimally position the sensor with respect to the specimen. For the measurement setup, two cameras are used (stereo setup) that are calibrated prior to measuring. The specific cracks contained observation area in this study is about 20mm x 18mm so that the software measuring volume that has been selected is 35mm x 29mm. The suitable lens size for this measuring volume is 75mm with resolution of 2448 x 2050 pixels (Titanar

75mm, sensor used is ARAMIS 5M) while for calibration of the cameras, CQ1CP20 30X24 calibration panel is used. To facilitate the correlation, a stochastic pattern is applied to the specimen surface in order to provide a random grey-level a variation at the sufficient quality of which is fundamental to the precision of the measured displacement data. The stochastic pattern in this study was created by black and white color sprays where black spray was first applied as the fundamental while white sprays was carefully applied above the black surface. After creating the measuring project in the software, images are recorded in various load stages of the specimen where the frame frequency is 0.5Hz. When the area to be evaluated is defined and a start point is determined, the measuring project is computed. During computation, ARAMIS observes the deformation of the specimen through the images by means of various square or rectangular image details, called facets (In this study the facet size is 18 x 18 pixels which gives 0.45mm x 0.45mm). A homogenous field of displacements is assumed inside each facet. The value of strain was calculated by differentiate the distribution of displacement. Hence, it is difficult to obtain a smooth strain distribution. So, in order to reduce the effect of the displacement measurement error, the displacement distribution was functionally approximated by a least squares method in ARAMIS, and then the strain was calculated by differentiating the function. The gage length is 0.4mm where in order to ensure the required accuracy of the measurement of displacements on a body surface, the individual facets are overlap by 2 pixels.

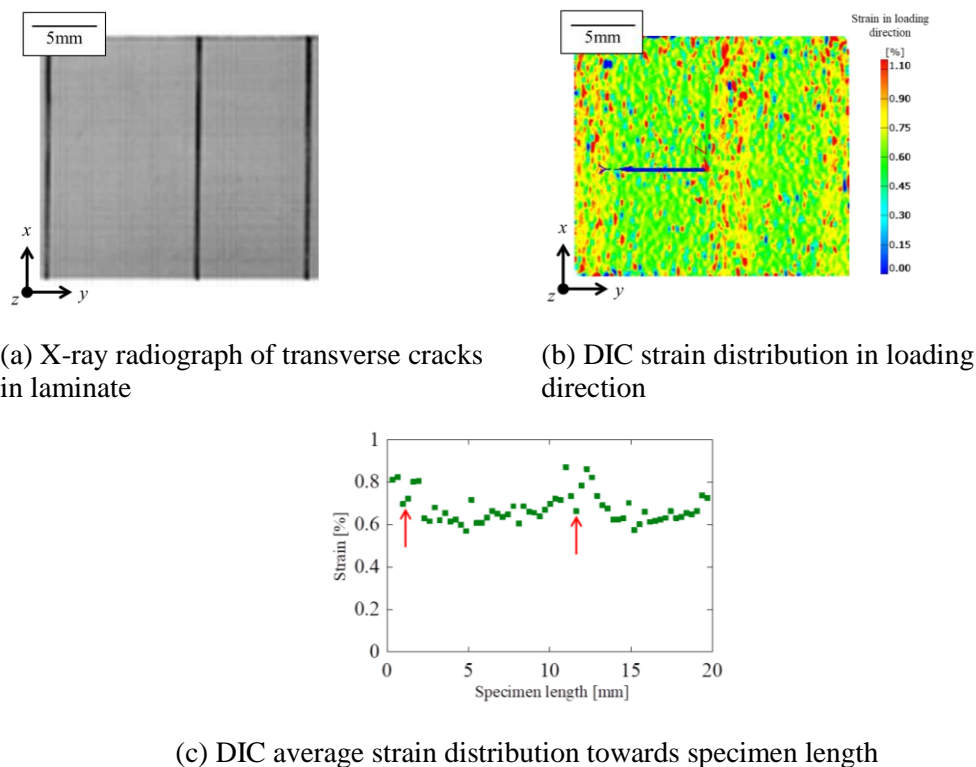
Figure 4: Crack observation from surface direction of $[0/90_6]_s$ laminate by (a) X-ray radiography (b) DIC.

A part of the laminate with three existed adjacent transverse cracks (Fig. 4(a)) is selected and the DIC strain distribution result for the selected area is shown in Figure 4(b). Figure 4(c) shows the plotted average strain distribution towards the specimen length. The direction y in the figure indicates the loading direction, x is width (straight transverse cracks) direction while z is the thickness direction of the specimen.

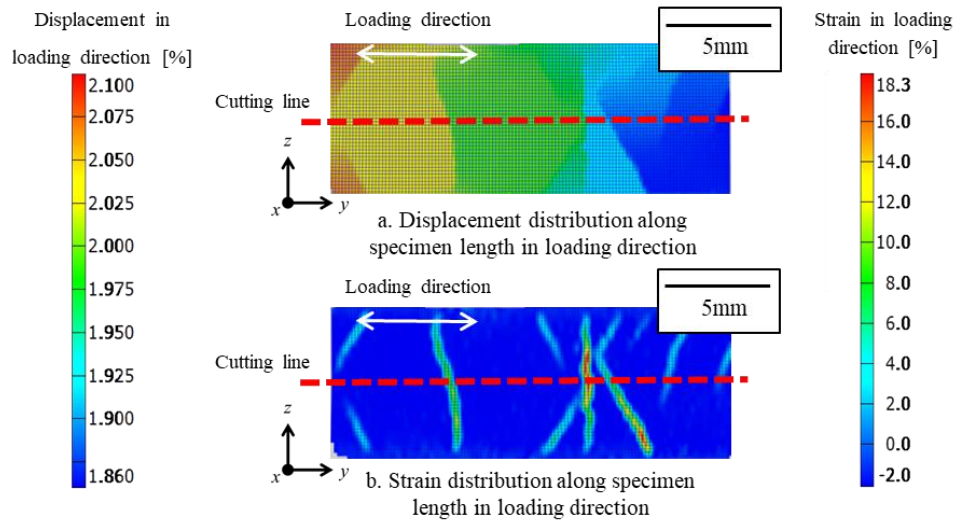
Figure 5: DIC observation from the thickness direction of $[0_4/90_{24}]_s$ laminate.

In order to investigate the phenomenon occurred in previous section, we tried to make a DIC strain observation from the thickness direction of the laminates. Unfortunately, due to the limitation of our DIC system to detect a very small measuring area which is the edge surface area of the $[0/90_6]_s$ laminate (with thickness of 2mm), we did only DIC strain observation from the thickness direction of thicker $[0_4/90_{24}]_s$ laminate with the edge thickness of about 8mm. Figure 5 shows the DIC observation from the thickness direction of $[0_4/90_{24}]_s$ laminate where (a) is the displacement distribution and (b) is the strain distribution. This figure shows that the cracks formed in 90 degree ply of the laminate are not only straight transverse cracks but also some other cracks called secondary damage mode's matrix cracks. This may be the reason why the strain value dropped at the center of the cracks area of DIC strain distribution as shown in Figure 4(b, c). In this figure we can see three distinctly different types of matrix cracks which are straight transverse cracks, oblique (partial angled) cracks and curved cracks. Curved crack is a matrix crack that initially forms as partial angled crack extending from the ply interface oriented at an angle less than 90 degree while oblique crack is a crack that forms incompletely through the off-axis ply near a straight crack. These cracks can be observed near a straight crack and grow toward the straight crack. There are also occurrences of two curved or oblique cracks located on one side of a straight crack. A similar observation is reported by Groves [7].

at the points with the highest shear strain. The larger distribution of shear strain in this area shows that this area has high accumulation of maximum principle stress. This may be the reason that caused the initiation of the oblique cracks seen in Figure 5(b). While for curved cracks, we can conclude that when two oblique cracks propagated from opposite side of each other, they meet and combine to become a curved shape near to the existed straight crack.

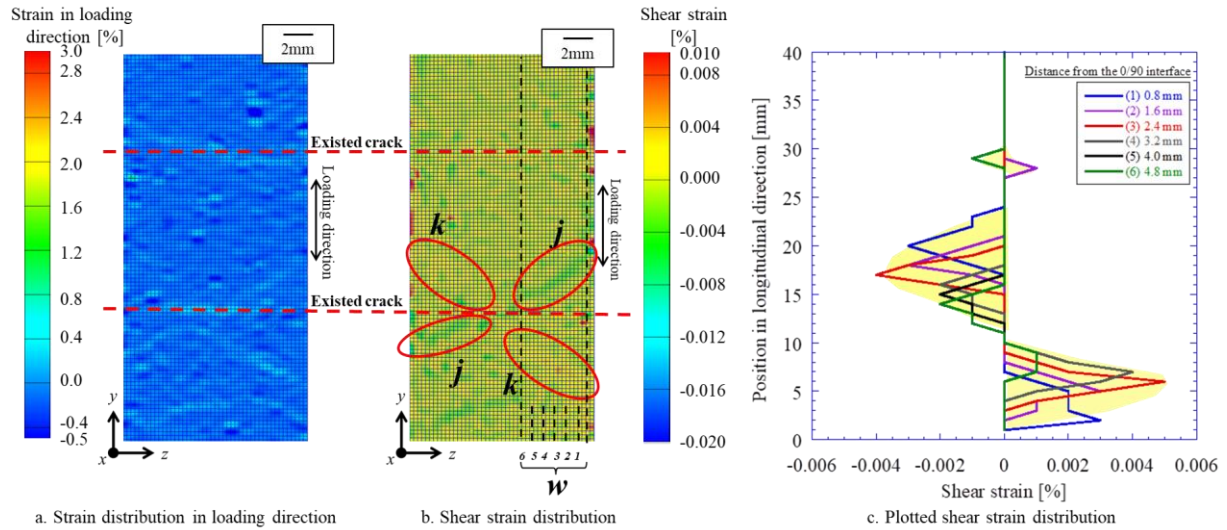
Figure 6: Strain distributions around the existed cracks before the formation of secondary damage mode of matrix cracking from the thickness direction of the specimen.

In order to explain the occurrence of the cracks in this secondary damage mode, we observed the DIC shear strain distribution from the thickness direction of the $[0_4/90_{24}]_s$ laminate. Figure 6 shows the DIC strain in loading direction and shear strain distribution observation at earlier stages where oblique and curved cracks have not yet occurred in this laminate. As shown in (b), shear strain in the red circles marked as ' k ' at the upper left and the lower right area near the straight crack is larger than the shear strain of other non-cracked area on the laminate. On the other hand, at the upper right and lower left area around the cracks highlighted with red circles marked as ' j ' showing a larger negative shear strain where this is a normal phenomenon where the shear strain value can be positive or negative value due to the symmetrical properties of matrix cracks in laminates. This can be observed clearly also in (c) where shear strain in straight lines along the specimen length labelled as 1-6 in w area in (b) is plotted against the specimen length. The area highlighted in yellow in this graph is the average shear strain value based on the shear strain at each point. From this relationship, we can observe the points where shear strain are highest and with the possibility of the initiation of the oblique cracks. This is then confirmed by comparing this figure to Figure 5(b), where the location of oblique cracks is exactly
